御嶽古道を歩いてみる

Walking along THE MITAKE OLD TRAIL

●御霊の渡し場の「場所性二次調査」実施平瀬から荒川を渡りて吉沢字桜本へ 考察 - その2、3

渡し場は何処にあったか 御霊の渡し考察 - その2 山梨大学名誉教授・工学博士 北村眞一 + 久保田要 (一部加筆) 20250324
Conducting a "secondary survey of the location" of the Goryo Ferry Pier: Crossing the Arakawa River from Hirase to Kissawa Sakuramoto.
Where was the ferry pier? A study of the Goryo Ferry Pier - Part 2, 3. Professor Emeritus of Yamanashi University, Doctor of Engineering,
Kitamura Shinichi and Kubota Kaname (with some additions). 20250324

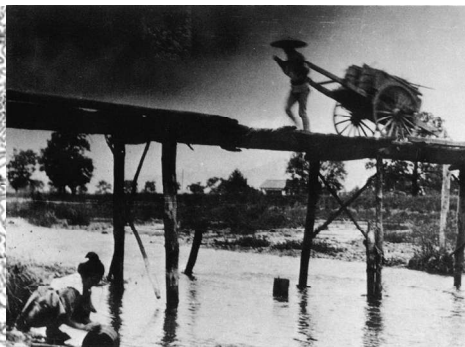
10 荒川から水害後の仮橋
明治四三年の大洪水で荒川にかかるほとんどの橋は流失した。泥水がひいたあと、軍隊や消防組が動員されて、丸太と角材と板だけの粗末な橋が架けられた。荷車がやっと通れるほどの狭い橋は、一年も経たないうちにこわれてしまった。本格的な架橋はなかなかおこなわれず、大正はじめごろの飯豊橋だろうか。

明治 43 年大水害の後、飯豊橋の仮橋

The temporary lide Bridge after the great flood of 1910 (Meiji43)

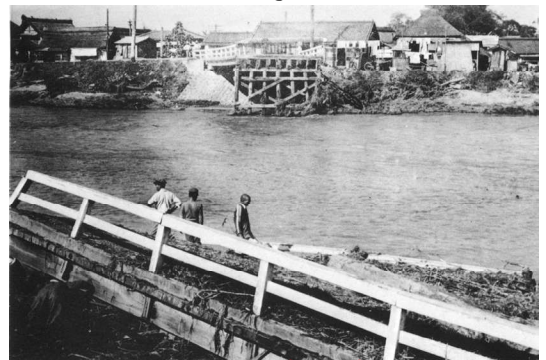
昭和 10 年千秋橋水害
1935 (Showa10) Senshu Bridge flood

・ In September 1935(Shouwa10), a typhoon caused heavy rainfall of 490 mm in Kofu, causing the Arakawa River to burst its banks in various places. Choshoji Bridge, Senmatsu Bridge, and Senshu Bridge were washed away, and flooding occurred in the Yamamiya, Chizuka, and Ikeda areas.

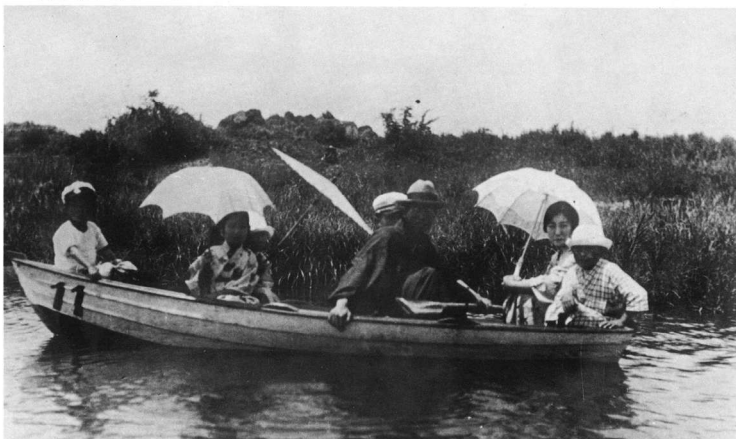
156
のどかを舟遊び
満州事変を頂点として、再
び好景気が訪れた。特にサラ
リマンは、おが世の春を謳
歌した。お花見、芝居見物、温
泉旅行と一家揃って行楽に浸
った古きよき時代であった。家
族全員で荒川の三ツ水門付近
で舟遊びするのどかな夏の風
物詩。昭和九年ころ撮影。

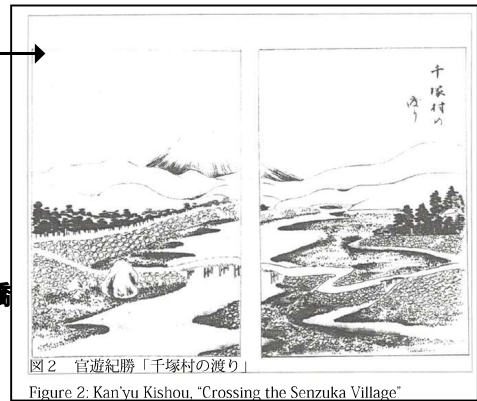
図2 官遊紀勝「千塚村の渡り」
Figure 2: Kan'yu Kishou, "Crossing the Senszuka Village"

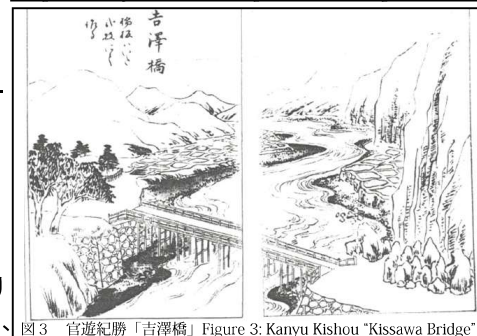
図3 官遊紀勝「吉澤橋」
Figure 3: Kan'yu Kishou "Kissawa Bridge"
